Wild Salmon Policy - Strategy 2: Fish Habitat Status Report for the Sucwoa River Watershed

Ian Wright, B.Sc., A.Ag.
Miranda deVisser, B.Sc., A.D.GIS, R.P.Bio
Michael C. Wright, B.Sc., R.P. Bio
M.C. Wright and Associates Ltd.
2231 Neil Drive
Nanaimo, BC V9R 6T5

Citation: Wright, I., M. deVisser and M.C. Wright. 2015. Wild Salmon Policy 2 – Strategy 2: Fish Habitat Status Report for the Sucwoa River Watershed. Unpublished report prepared for the Nootka Sound Watershed Society.

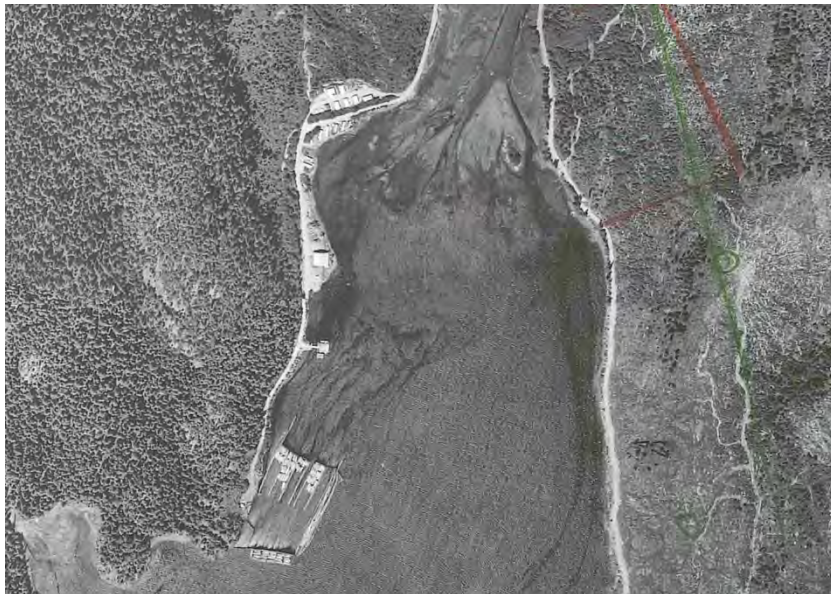
Photo 3. Sucwoa River estuary in 1977. Note the booming ground and industrial land use along the west shore.

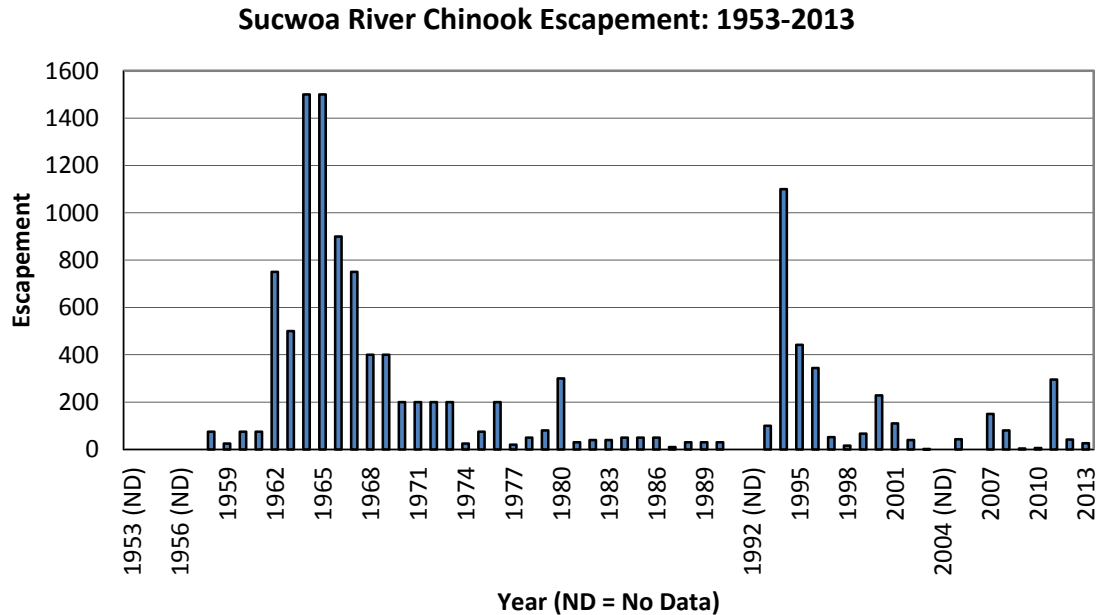
The Sucwoa River has historically been a consistent producer of chinook salmon with average annual escapements of approximately 400 fish between 1958-1978. Historical escapements up to 1,500 fish were recorded in the mid-1960s, dropping back to counts between 20 and 300 until 1995 where numbers again increased to 1,100 adults. Recent escapement estimates range between 26 to 295 fish (Figure 7).

Figure 7. Chinook escapement in the Sucwoa River between 1953 and 2013 (compiled from DFO's NuSEDs database).

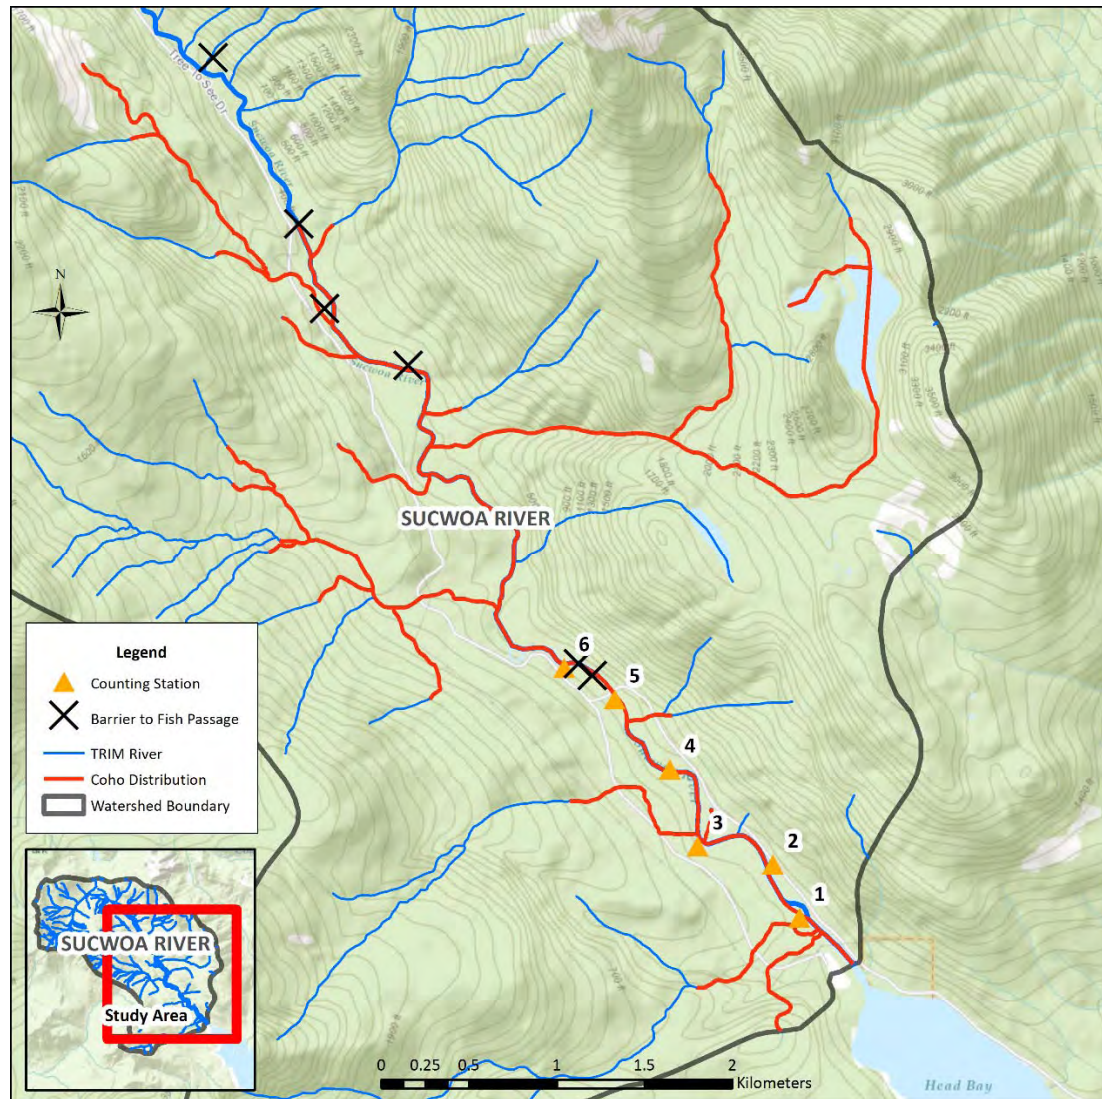
Figure 8. Known and inferred coho distribution in the Sucwoa River watershed.

Coho salmon typically arrive in the Sucwoa River in mid-September and begin spawning in late October. Peak spawning typically occurs in mid-November, with the end of the run observed in late November (Fisheries and Oceans Canada, 2015). Distribution has been observed in the mainstem up to an anadromous barrier falls located approximately 6.4km upstream from the river mouth. Additionally, coho distribution extends into a number of tributaries, the majority providing less than 1km of accessible stream length, but four tributaries provide over 2km of access, one of which is over 4km long with an accessible 180m² headwater lake (Figure 8).

Figure 8, Figure 13, and Figure 16, the following table summarizes accessible stream length by species:

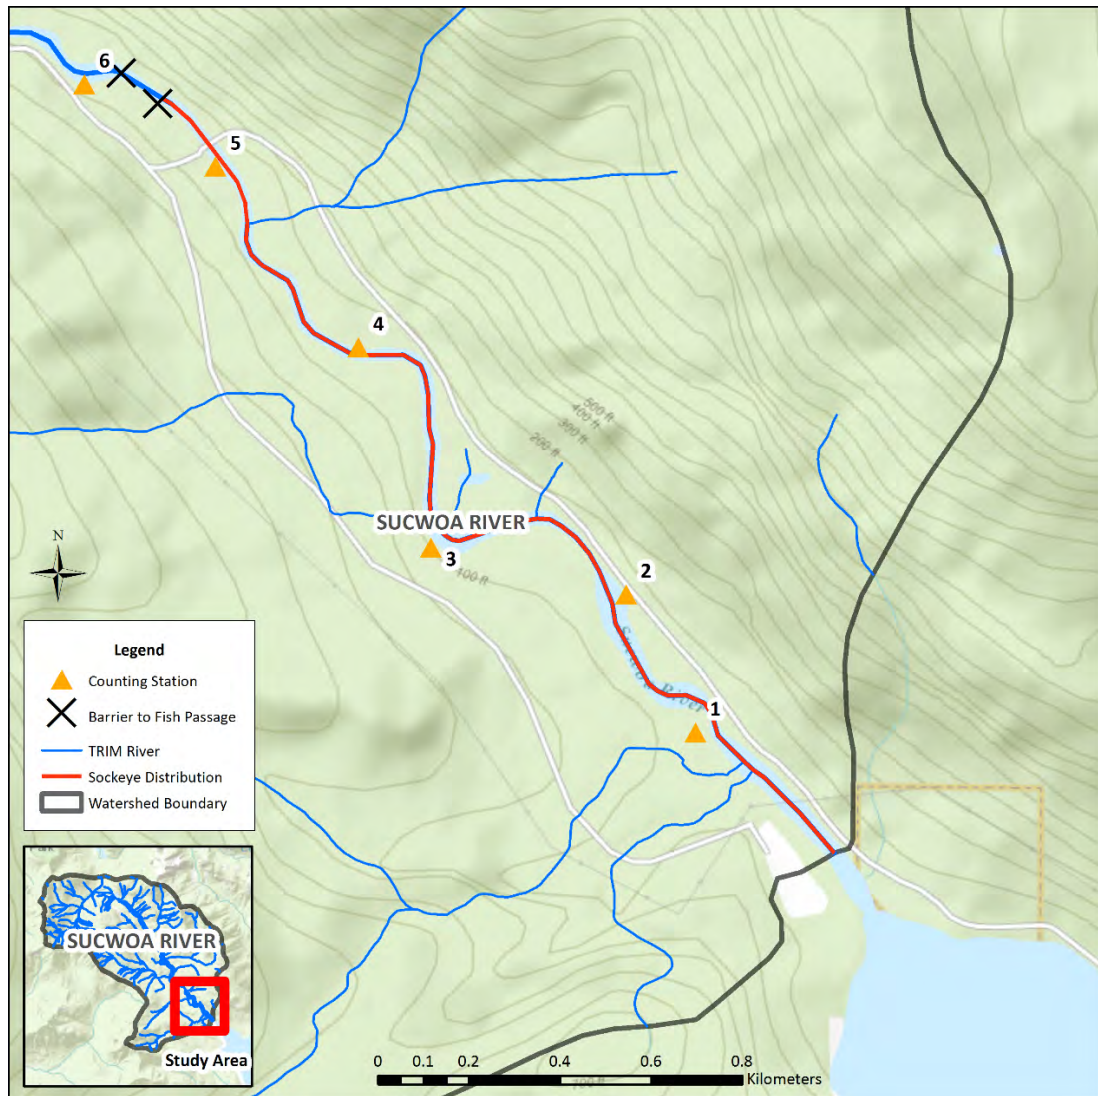
Figure 13. Known sockeye distribution in the Sucwoa River watershed.

Sockeye arrive in the Sucwoa River in mid-August and begin spawning in late October. Peak spawning is observed in early November, and spawning is typically over by mid-November (Fisheries and Oceans Canada, 2015). Distribution is known up to the barrier between counting stations 5 and 6 (Figure 13). Excellent holding habitat known locally as "Larry's tree" is located between counting stations 1 and 2. The pool at the bridge (counting station 5) is important for sockeye, which arrive there early and hold in the pool all fall before spawning downstream. (Fisheries and Oceans Canada, 2015)

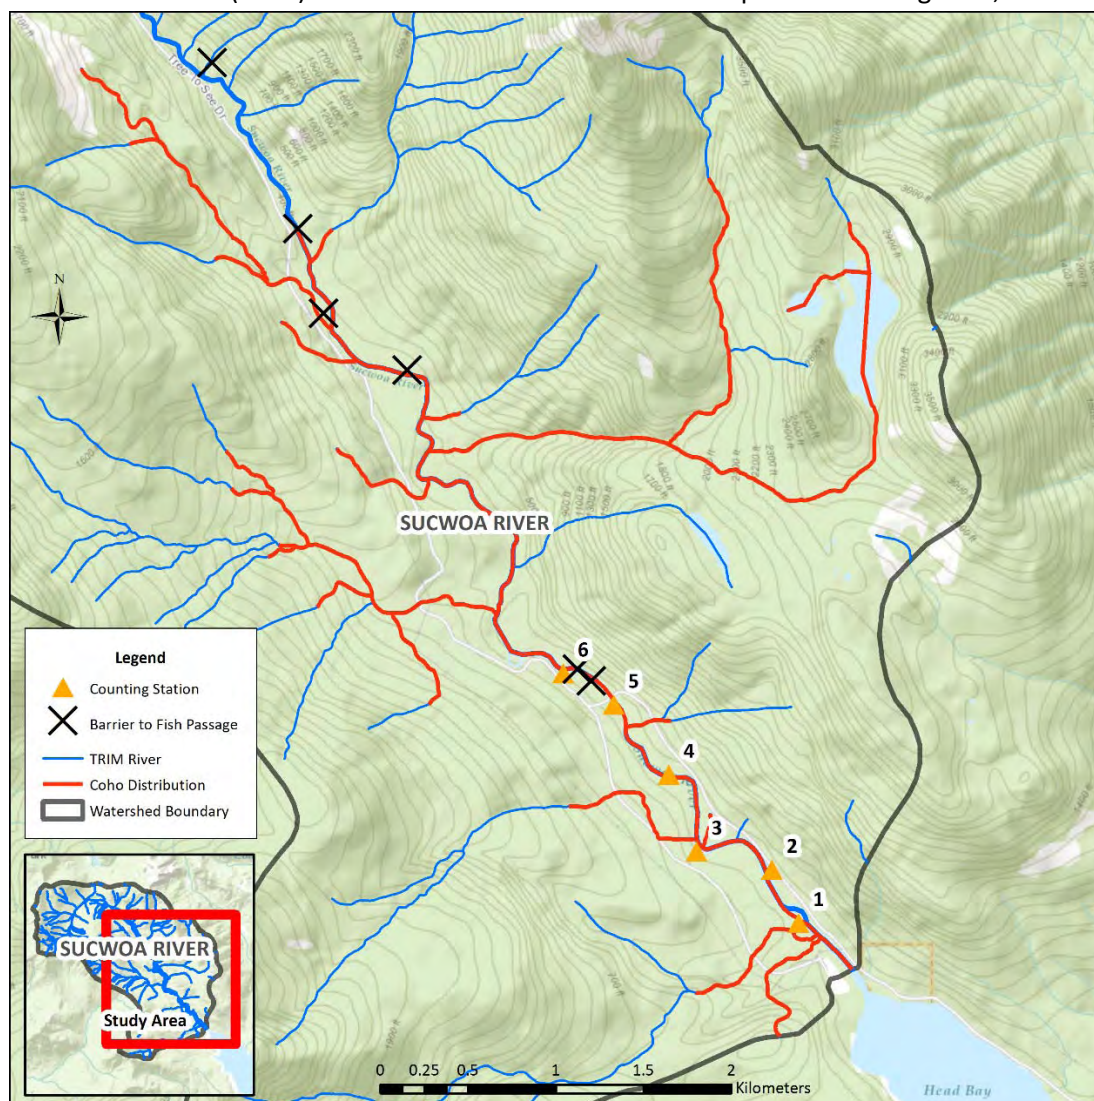
Information on accessible stream length for the Sucwoa River watershed was compiled from the Sucwoa River stream narrative (Fisheries and Oceans Canada, 2015), FISS, and accounts from Glova and McCart (1978). Based on the GIS distribution data presented in Figure 4,

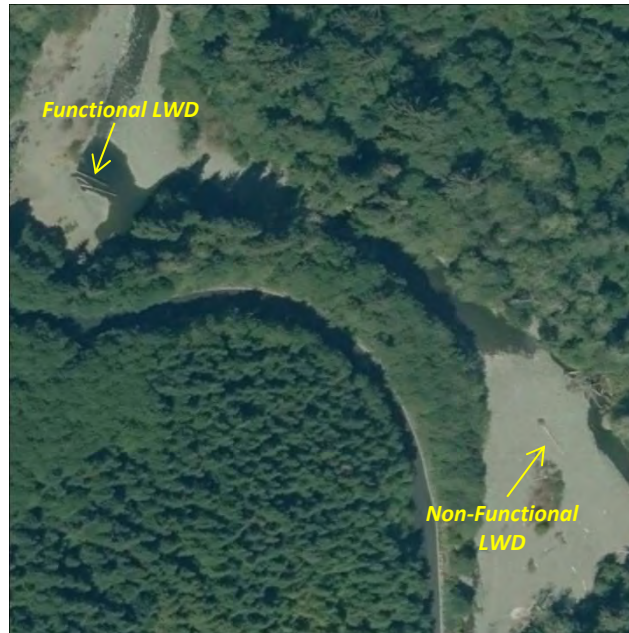
Photo 4. Example of functional LWD and non-functional LWD in the Sucwoa River.

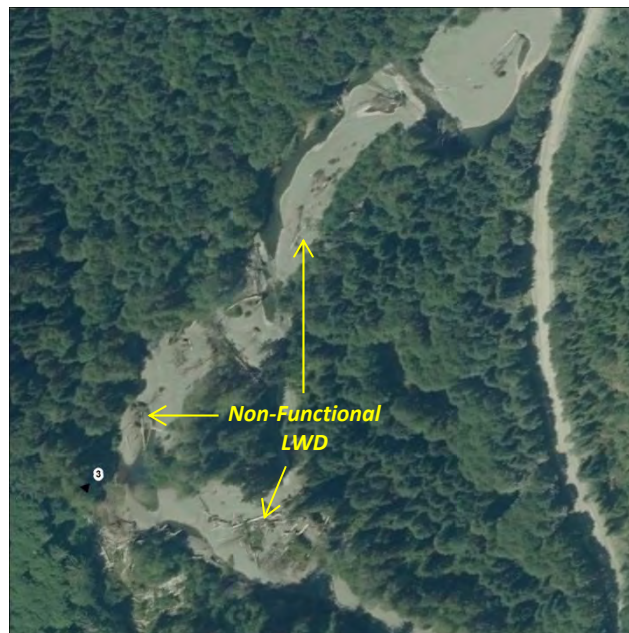
Photo 5. Example of non-functional LWD near counting station 3 of the Sucwoa River.

Debris jams were most common throughout reach 1, with the largest jam observed just downstream of counting station 3. In most cases these jams were providing functional fish habitat and in some locations preventing further bank erosion.

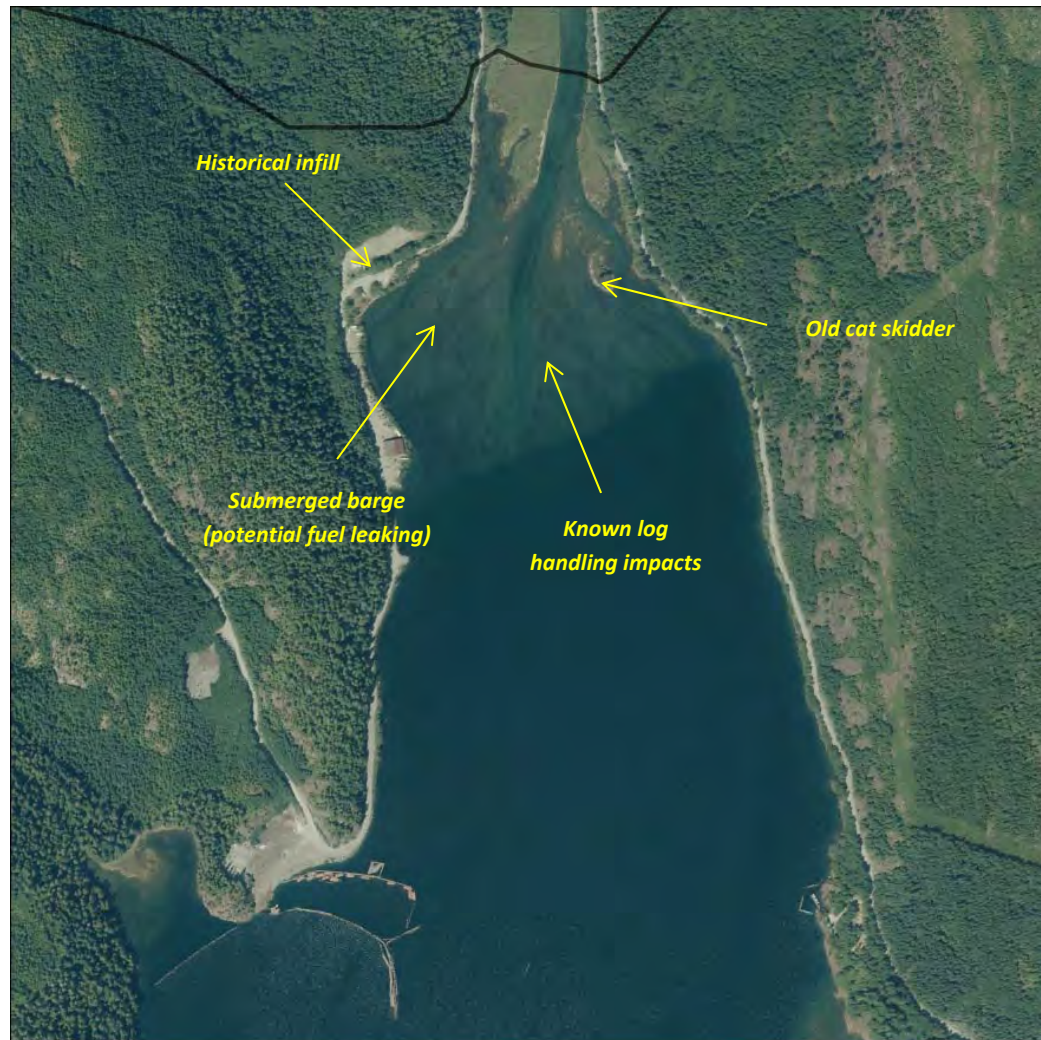
In comparison to other systems in the area, the Sucwoa estuary was identified as one of the most heavily degraded (NSWS, 2015). Industrial lands have occupied approximately 400m of the foreshore on the west side of the estuary since 1954, and the estuary continues to be bordered on both sides by active roads. An active log dump is situated approximately 600m south of the river delta on the west shore. Log booming activity was observed as close as approximately 100m from the visible delta in 1954, and that distance increased to approximately 600m by 2013. Significant historical fill exists within the estuary, with commercial debris (i.e. scrap metal, fuel tanks, etc.) likely present within this fill. Derelict equipment (including a sunken barge and an abandoned cat skidder) exists within the estuary and reports of fuel leaking from this equipment have been noted (NSWS, 2015). Further field investigation would be necessary to assess the impacts of past forest harvesting on the Sucwoa River estuary, such as excessive sedimentation deposition (resulting from bank erosion from riparian logging) and/or wood waste accumulation from log handling.

Based on historical and current aerial imagery interpretation of permanent alterations to the Sucwoa River estuary, and information gathered from local experts, this habitat indicator has been ranked as high risk. Note the condition of subtidal estuarine habitat has been identified as a data gap.

Figure 33. Present-day habitat disturbances in the Sucwoa River estuary.

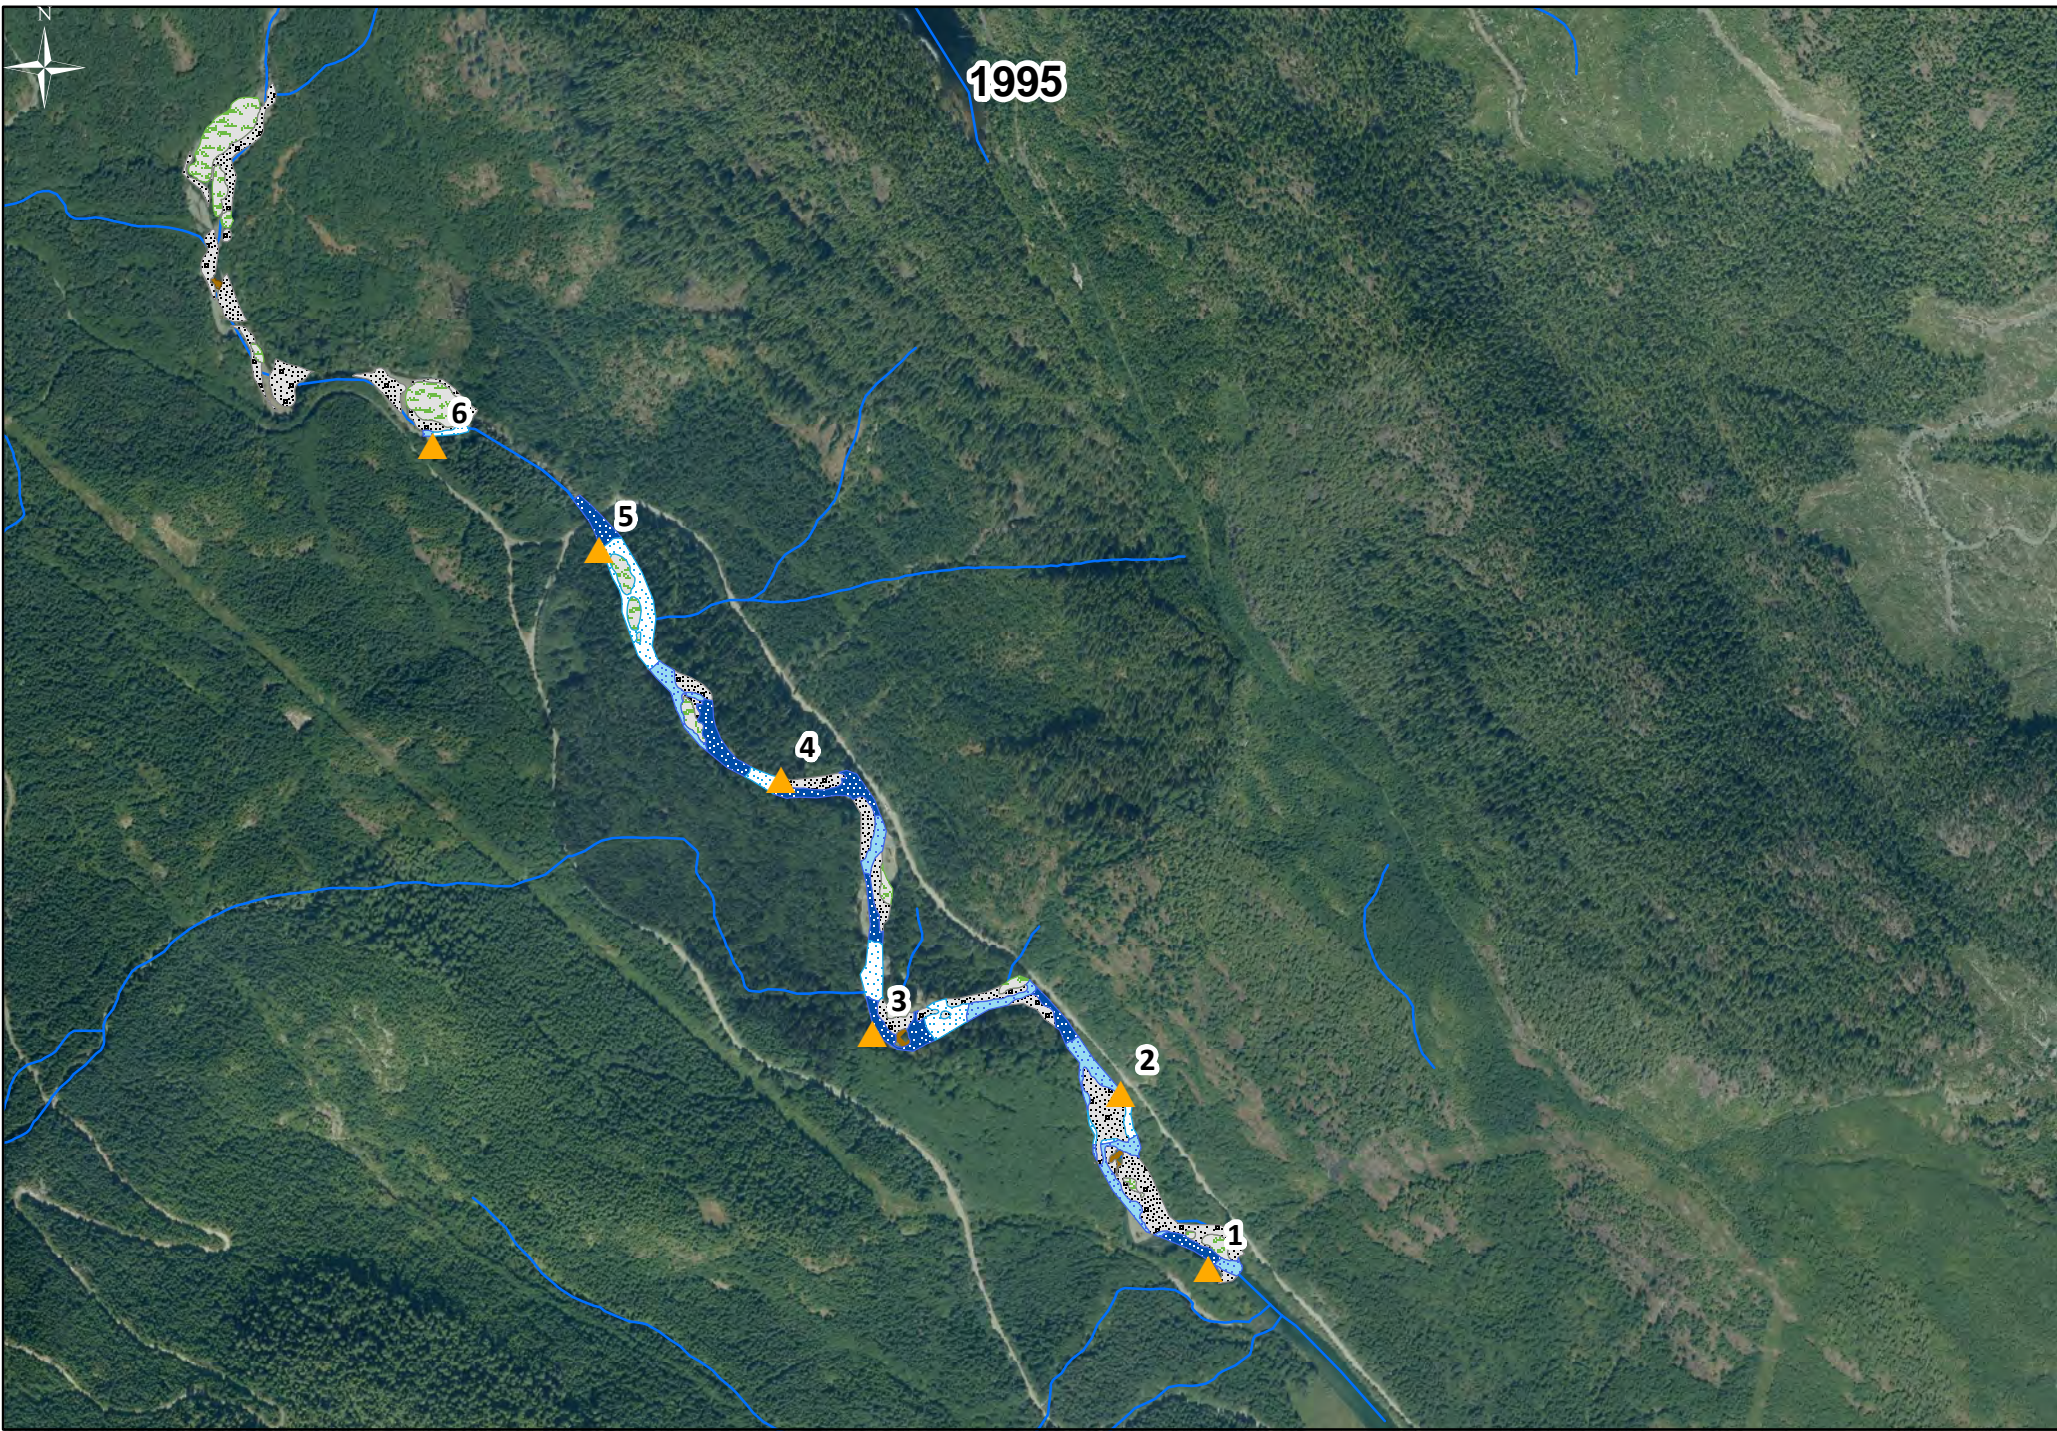
MAP 15

**Sucwoa River Watershed
Riparian Disturbance**
