# Wild Salmon Policy - Strategy 2: Fish Habitat Status Report for the Canton Creek Watershed

Miranda deVisser, B.Sc., A.D.GIS, R.P.Bio,  
Brandalyn Musial, B.Sc., R.P.Bio, and  
Michael C. Wright, B.Sc., R.P. Bio  
M.C. Wright and Associates Ltd.  
2231 Neil Drive  
Nanaimo, BC V9R 6T5

**Citation:** deVisser, M. B. Musial and M.C. Wright. 2015. Wild Salmon Policy 2 – Strategy 2: Fish Habitat Status Report for the Canton Creek Watershed. Unpublished report prepared for the Nootka Sound Watershed Society.

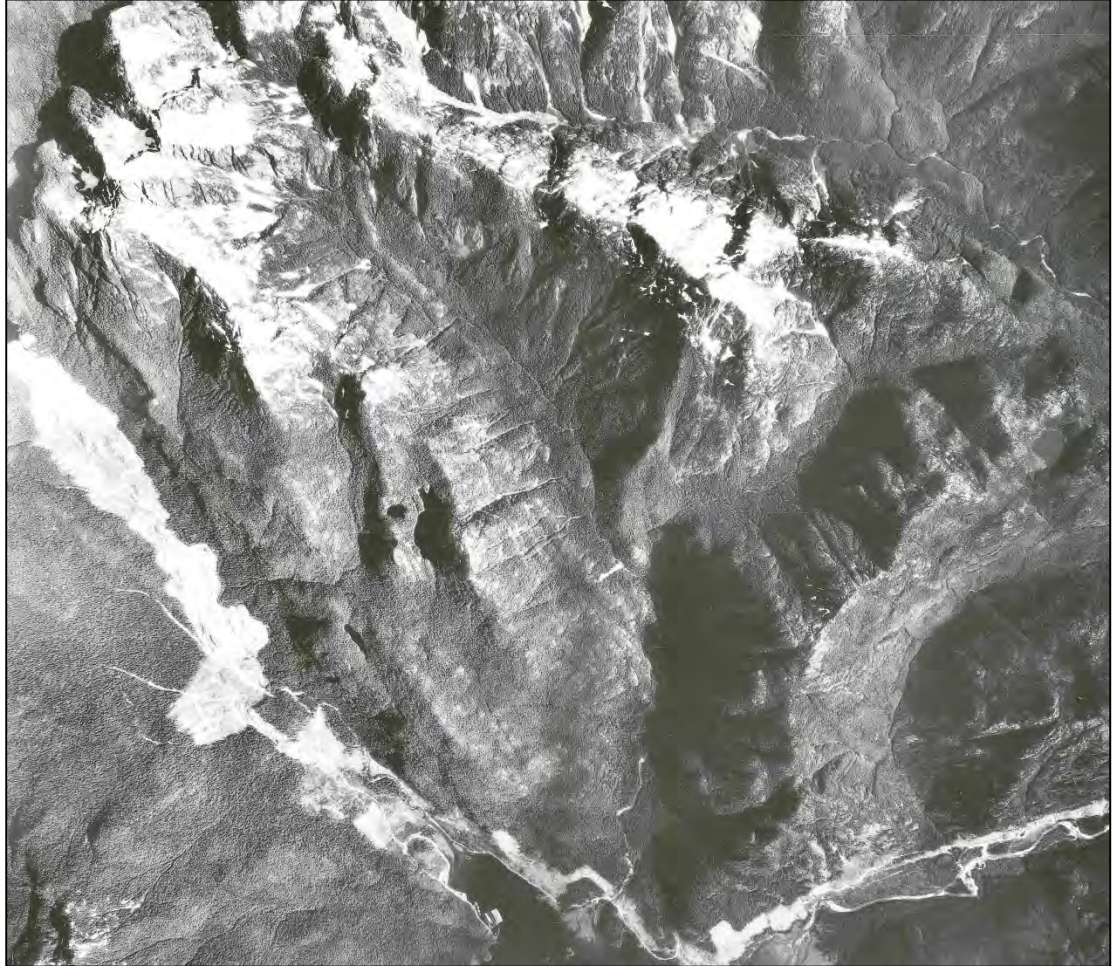
**Photo 1. Canton Creek watershed in 1954, prior to forest harvesting. Note heavy harvesting in the adjacent Sucwoa River watershed.**

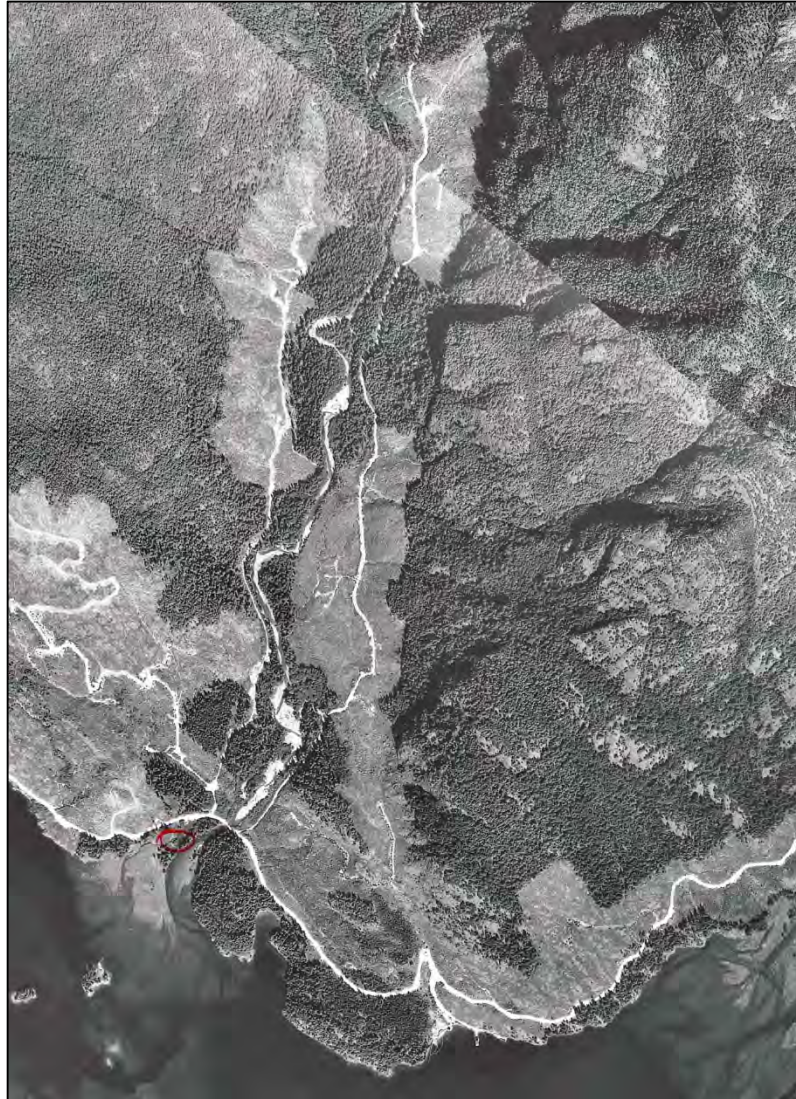
**Photo 2. Forest harvesting adjacent to lower Canton Creek in 1980.**

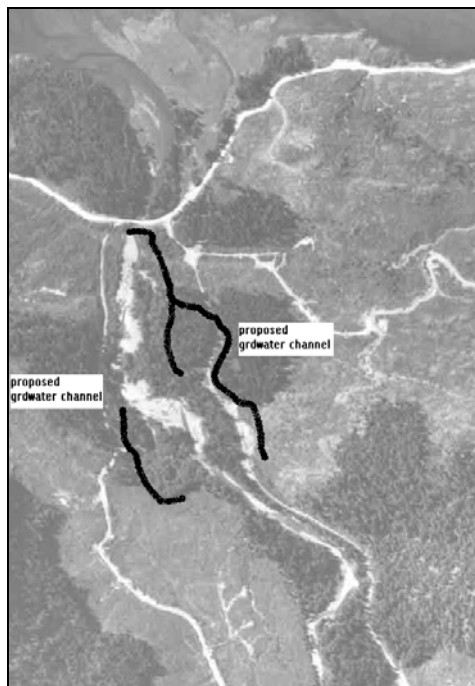
**Photo 3. Proposed location of groundwater channels in Lower Canton Creek (Fisheries and Oceans Canada, 2007)**

In 2007, a proposal was developed by Fisheries and Oceans Canada to construct groundwater channels along the left and right banks of Canton Creek, with the intent of improving both chum and coho salmon productivity levels (Photo 3). While 10 shallow test pit wells were installed along the left bank in 2004 as part of a feasibility study, no further construction with respect to this project occurred (Fisheries and Oceans Canada, 2007).

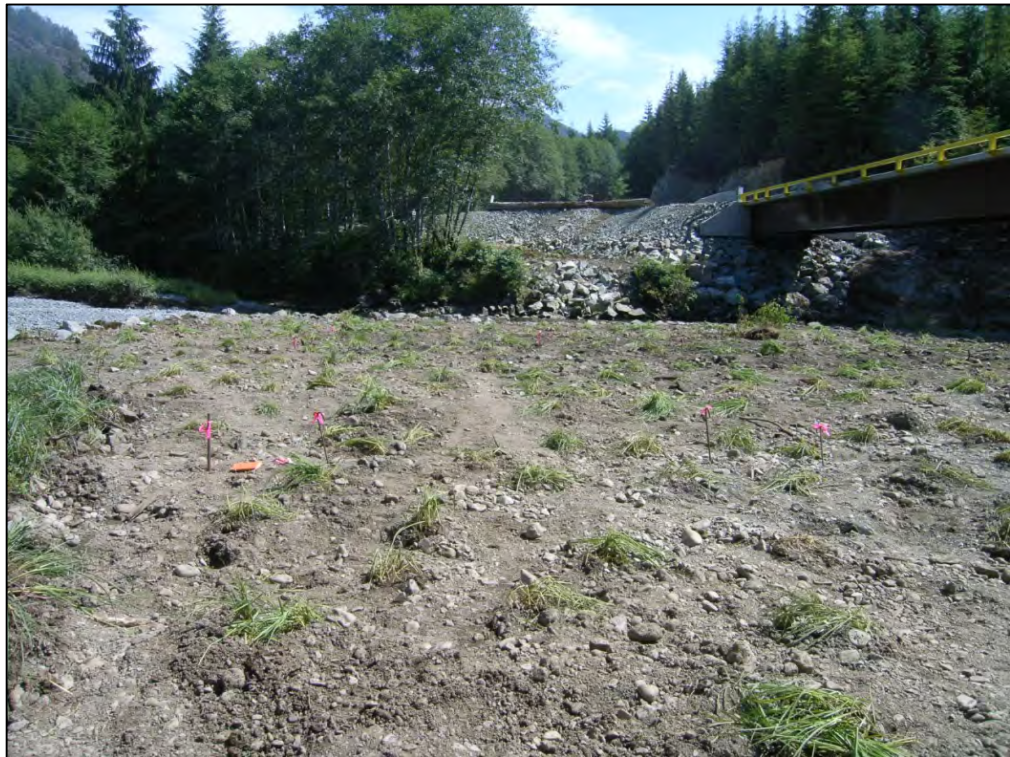
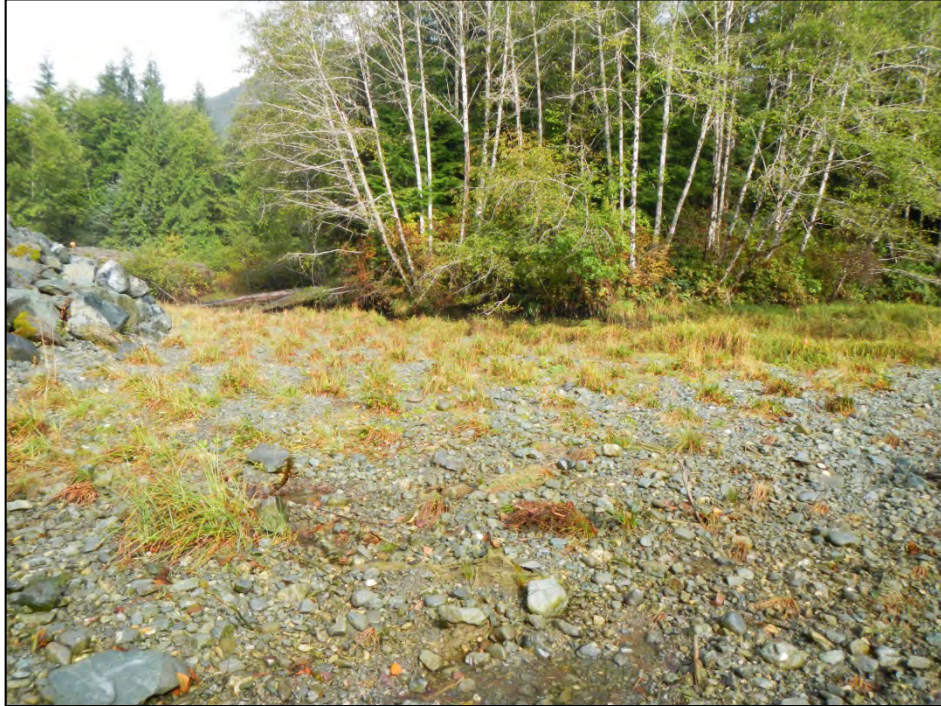
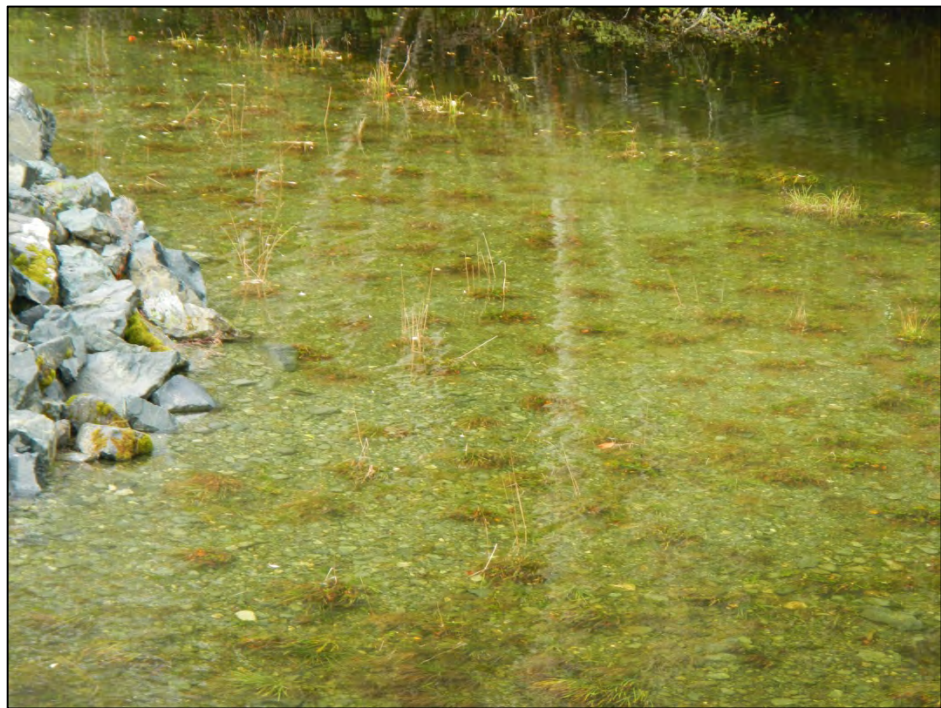
**Photo 4. Reclaimed and transplanted sedge habitat along the right bank of the Canton Creek bridge.**

**Photo 5. Reclaimed and transplanted sedge habitat along the right bank of the Canton Creek bridge.**

**Photo 6. Reclaimed and transplanted sedge habitat along the right bank of the Canton Creek bridge.**

In 2012, replacement of the Head Bay FSR 41.7km bridge (i.e. Canton Creek bridge) occurred. This new bridge was installed just downstream of the old bridge, resulting in re-alignment of Head Bay Road at the bridge crossing. In an effort to improve productivity levels in Canton Creek the deactivated road prism (and old right bank bridge footing) was reclaimed through the excavation of old fill down to elevations that would support sedge habitat. Following excavation, this area was transplanted with sedges from estuarine habitat within Canton Creek (Photo 4, Photo 5, and Photo 6) (Musial et al, 2012). Recent observations have demonstrated high transplant survival rates and overall expansion of vegetated areas (M.C. Wright and Associates, in-field observations).

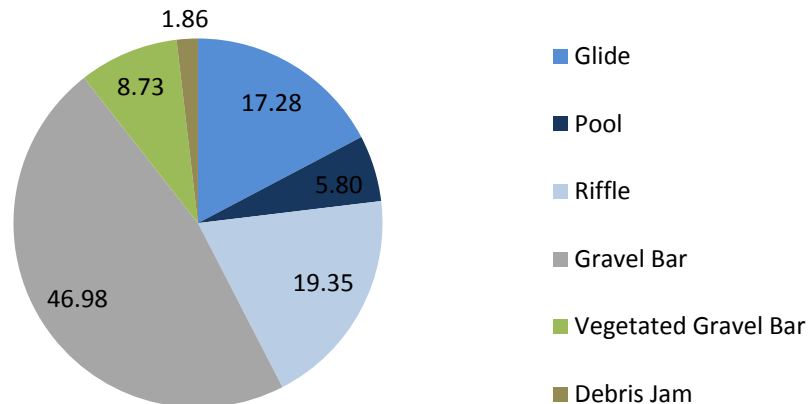
**Figure 28. Habitat unit composition (2013) for Canton Creek between counting stations 0 and 7.**

The benchmarks described in Johnston and Slaney (1996) indicate that for systems less than 15m and with gradients of <2%, poor salmonid habitat condition for summer and winter rearing occurs with <40% pool habitat area by reach. Similar conditions are experienced in systems with gradients between 2% and 5% where <20% pool habitat area is observed. While Canton Creek is greater than 15m in average width, this metric still provides a useful comparison of pool habitat composition. When gravel bars, vegetated gravel bars, and debris jams are removed from the composition analysis, percent pool habitat increases from 5.80 to 13.68%. Considering this value still remains below the suggested benchmark, the habitat composition indicator for Canton Creek has been classified as high risk, as pool frequencies in the system remain well below the suggested benchmarks.

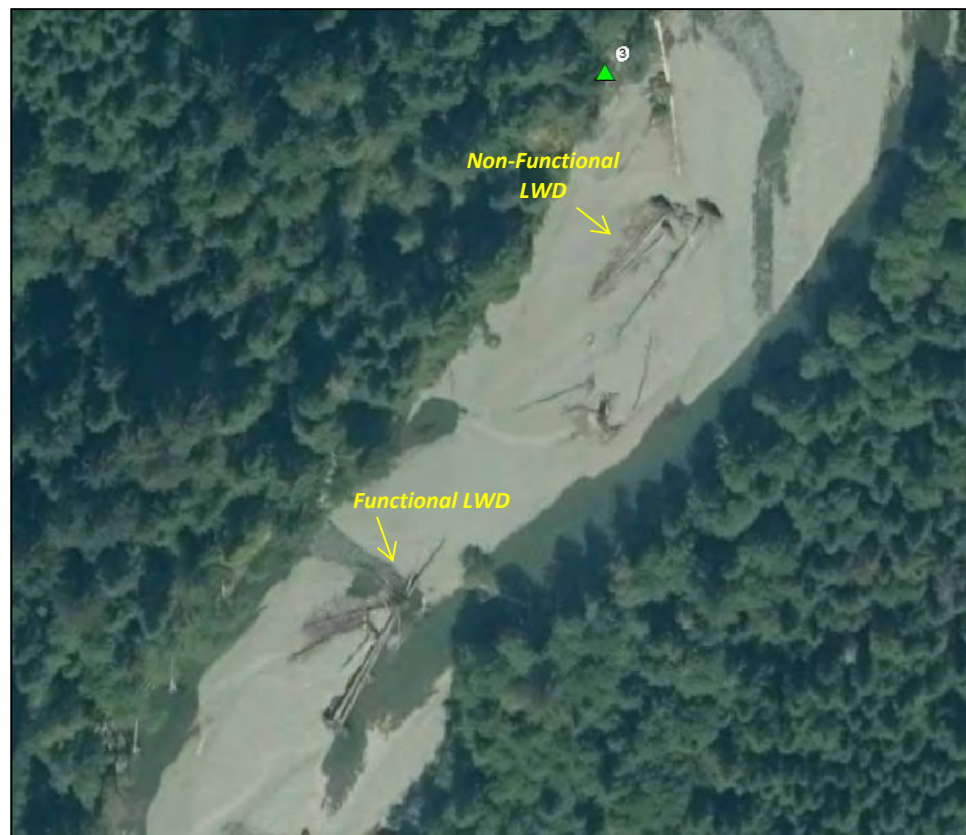
**Photo 7. Non-functional and functional LWD observed just downstream of Counting Station 3.**

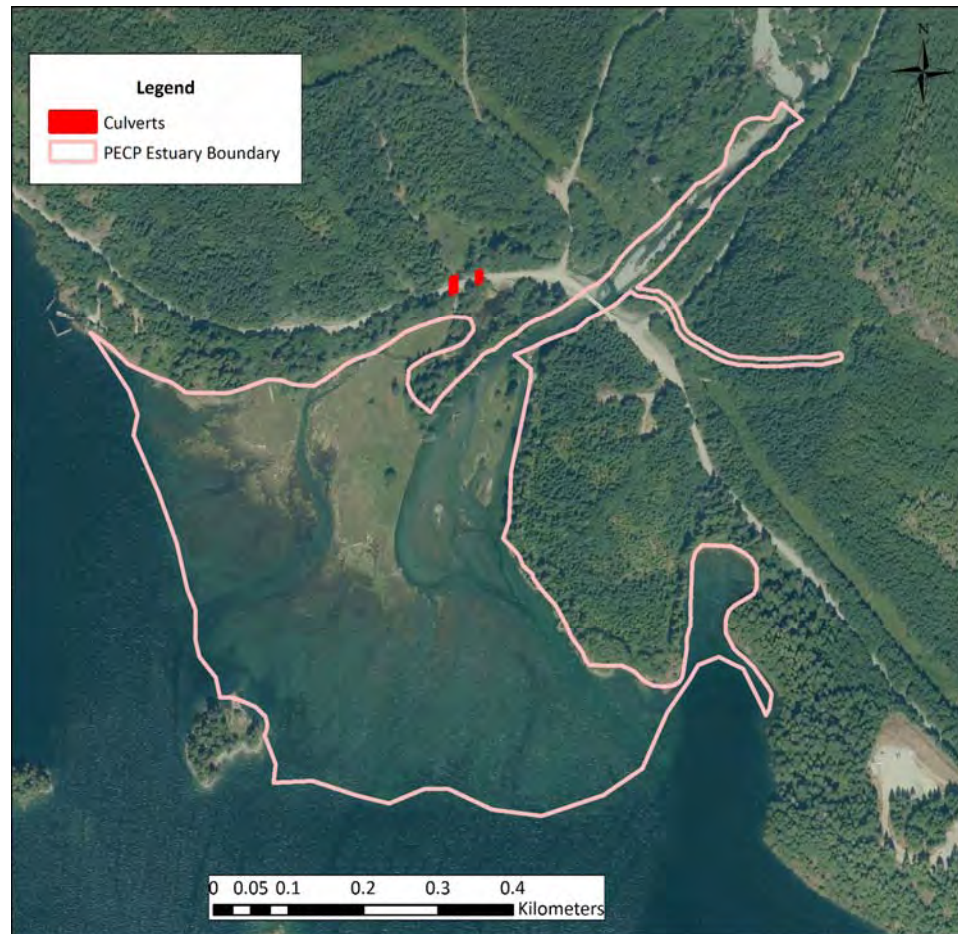
**Figure 32. Known present-day habitat disturbances to the Canton Creek estuary.**

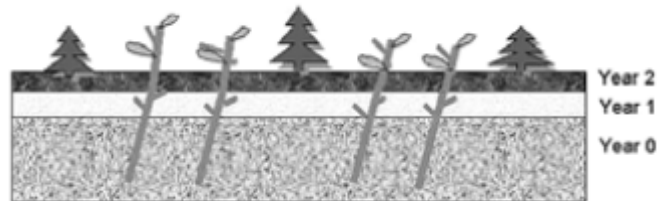
**Figure 36. Live gravel bar staking resulting in eventual re-vegetation of gravel bars.**

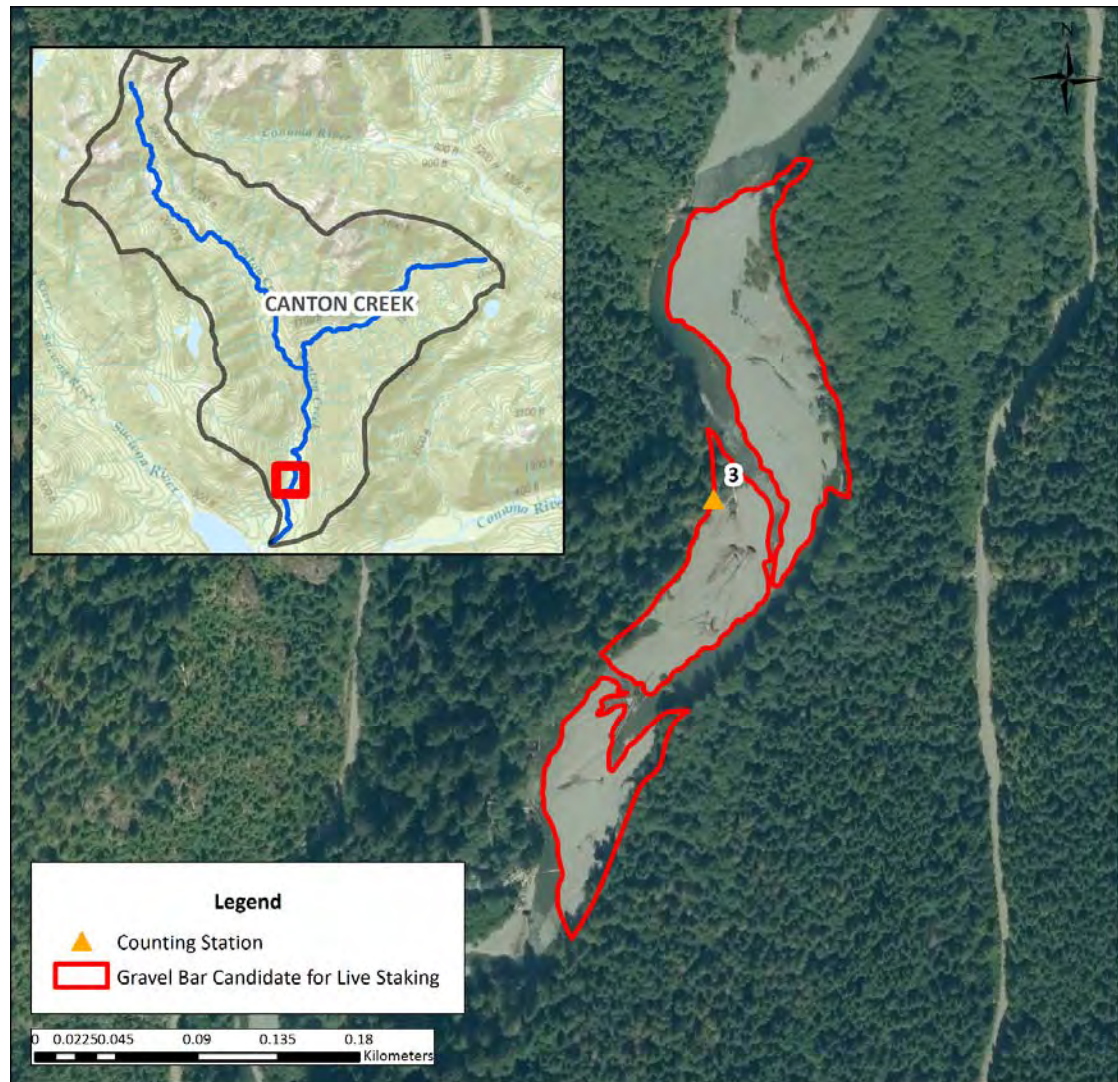
Figure 37. Candidate sites for live gravel bar staking in Canton Creek.

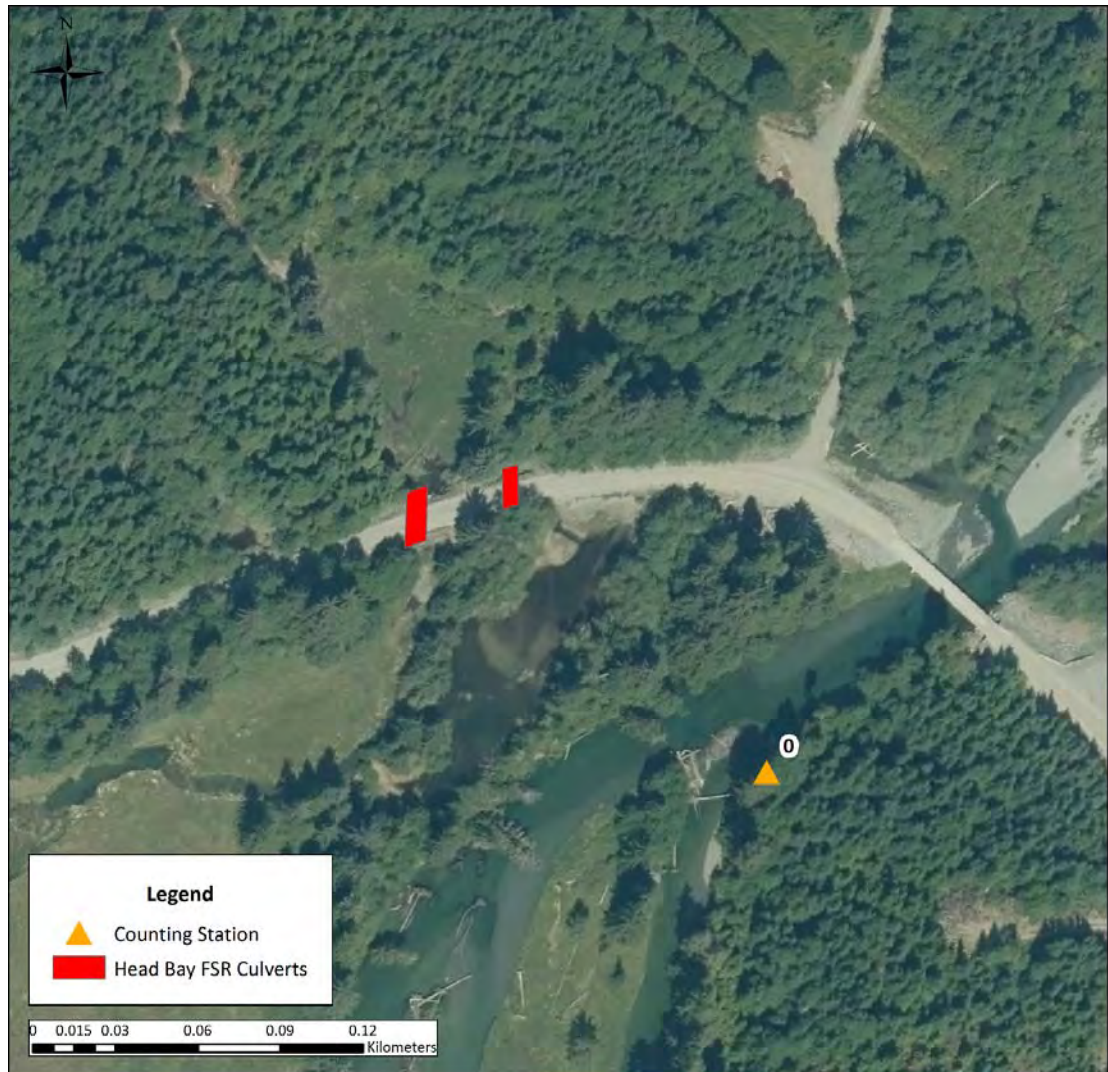
Figure 39. Location of culverts restricting fish access along Head Bay FSR.

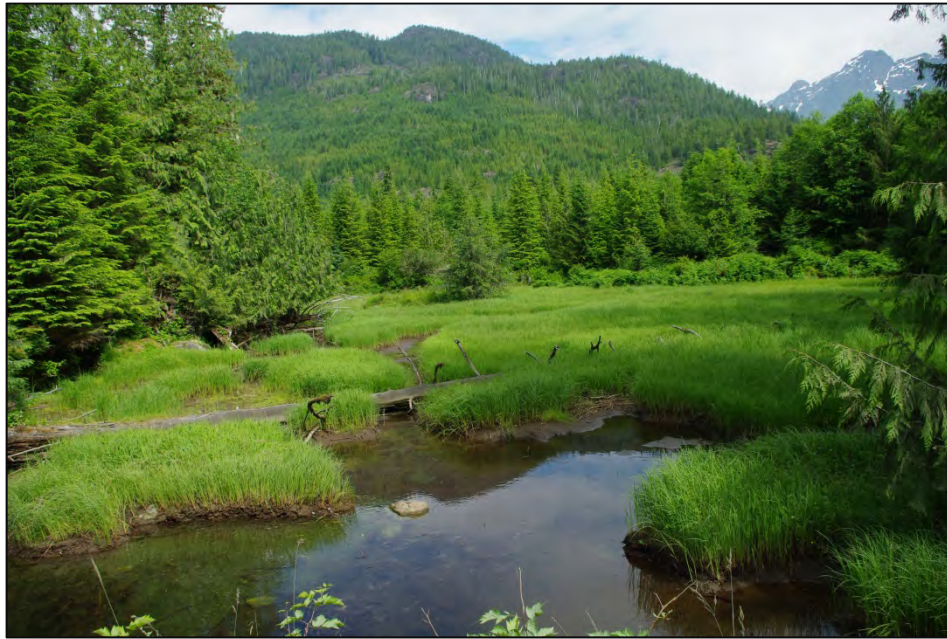
**Photo 8. High value salt marsh habitat upstream of the Head Bay FSR culverts.**

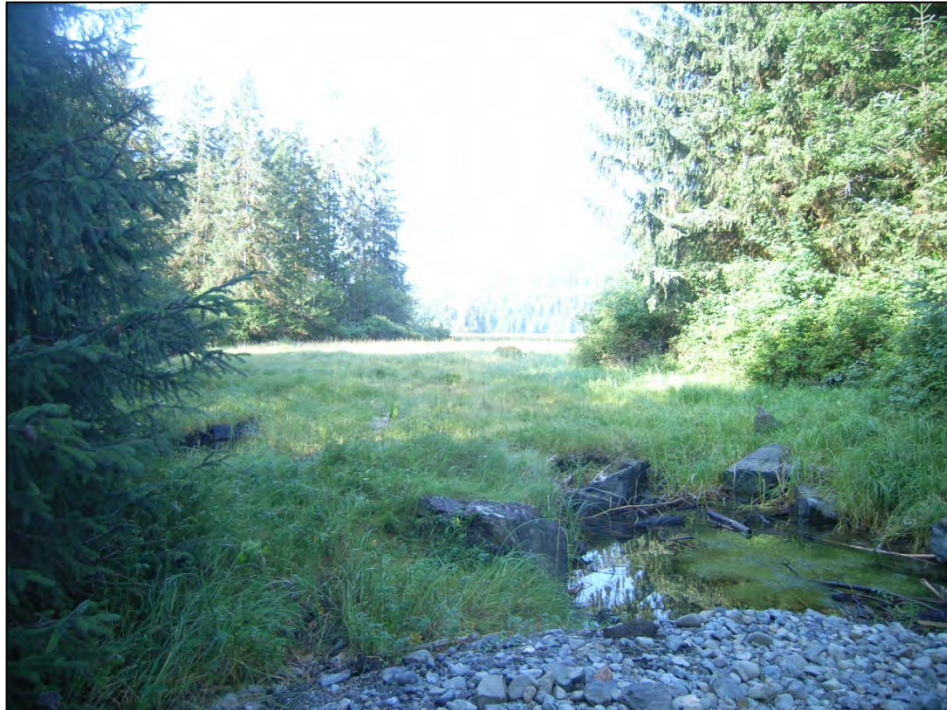
**Photo 9. Estuarine habitat downstream of the Head Bay FSR culverts.**

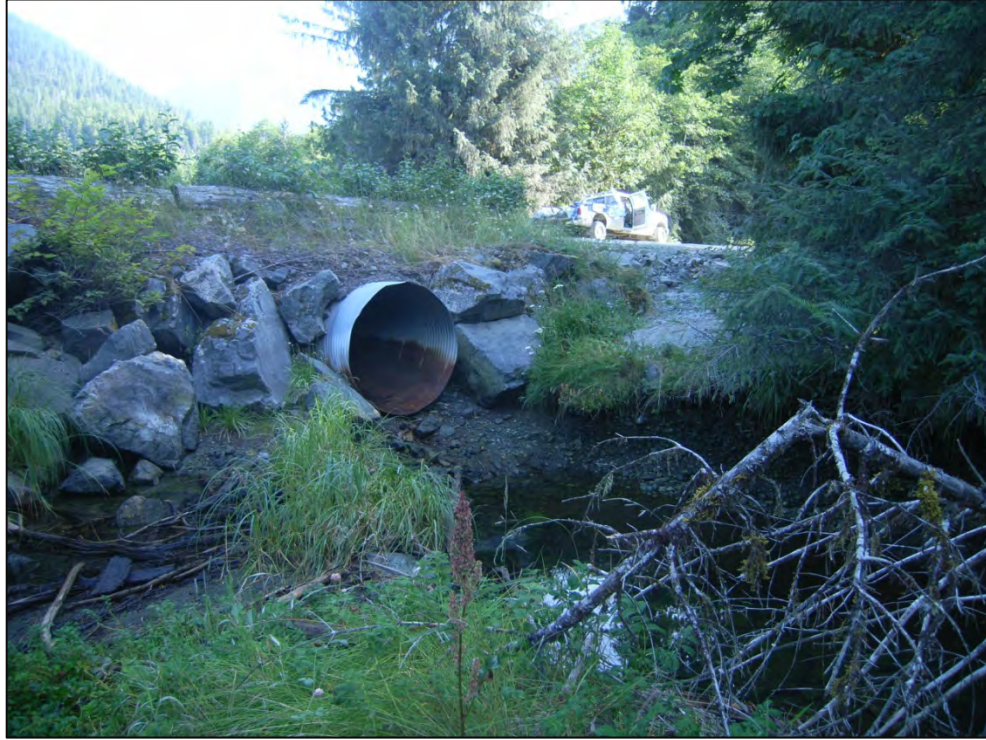
**Photo 10. Head Bay FSR culvert restricting fish passage.**
