# Wild Salmon Policy - Strategy 2: Fish Habitat Status Report for the Conuma River Watershed

Nootka Sound Watershed Society  
P.O. Box 293  
Gold River, B.C.  
V0P 1G0

Ian Wright, B.Sc., A.Ag.  
Miranda deVisser, B.Sc., A.D.GIS, R.P.Bio  
Michael C. Wright, B.Sc., R.P.Bio  
M.C. Wright and Associates Ltd.  
2231 Neil Drive  
Nanaimo, BC V9R 6T5

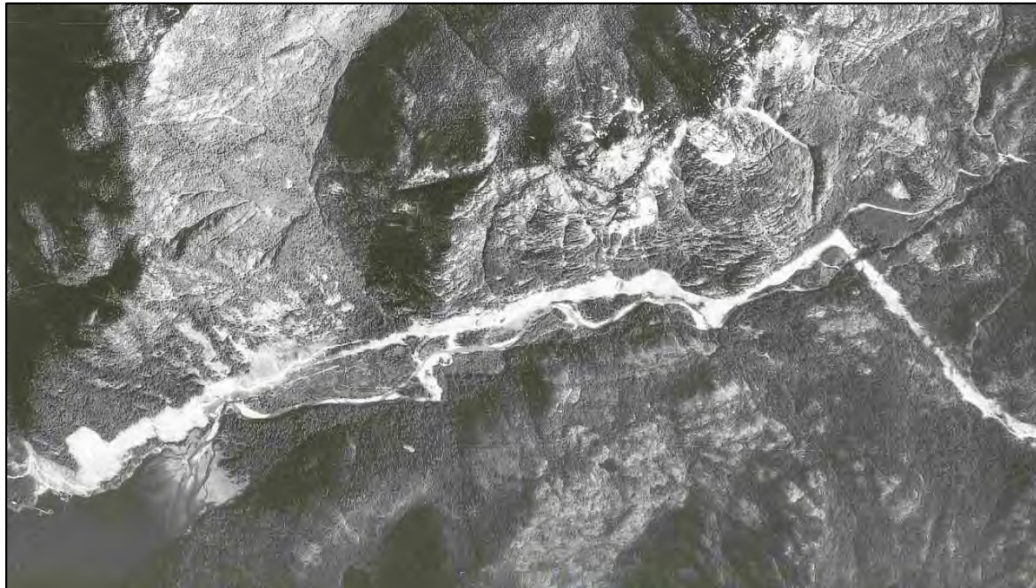
**Photo 1. Vegetation removal associated with hydro line construction in the lower Conuma River watershed in 1954.**

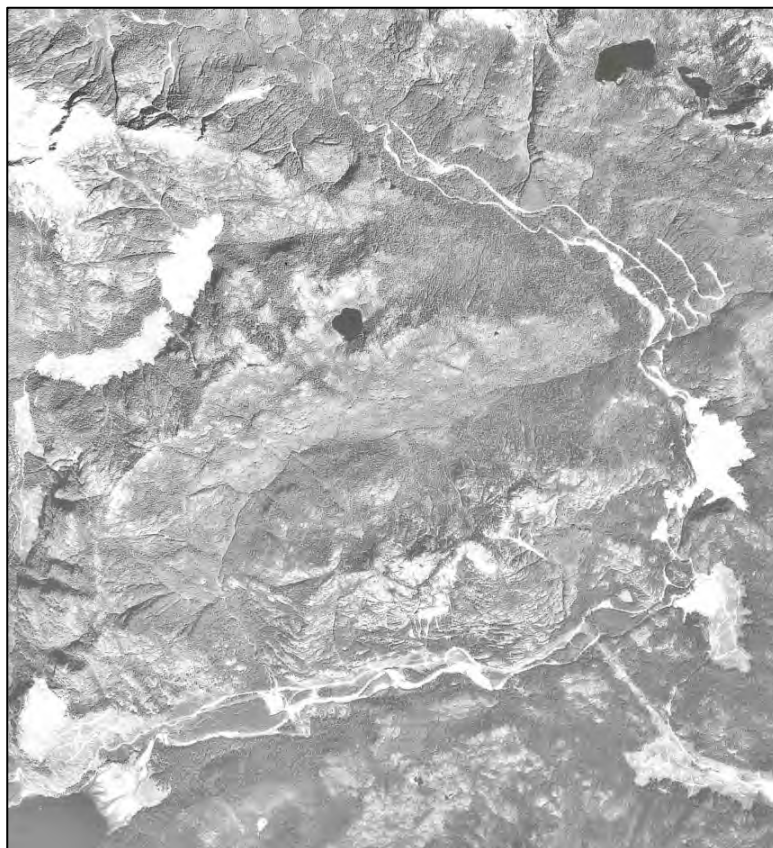
**Photo 2. Continued logging activity in the Conuma River watershed in 1987. Note the large mid-watershed clearcuts extending into the riparian zone and the road extension into the upper watershed.**

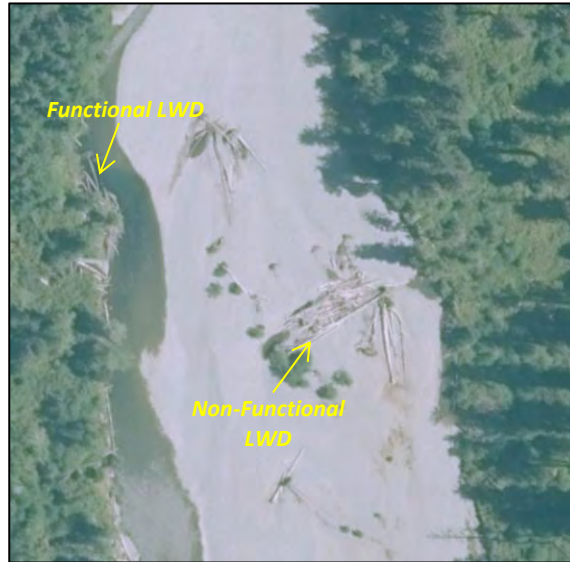
Non-functional LWD was present throughout the system, primarily present as wood accumulating on top of gravel bars (Photo 4). There was also a considerable component of this wood that was oriented parallel to the stream bank, and was therefore providing limited function to the system.

**Photo 4. Example of functional LWD and non-functional LWD in the Conuma River.**

Based on the lack of functional LWD observed in the Conuma River, this habitat indicator was ranked as high risk.

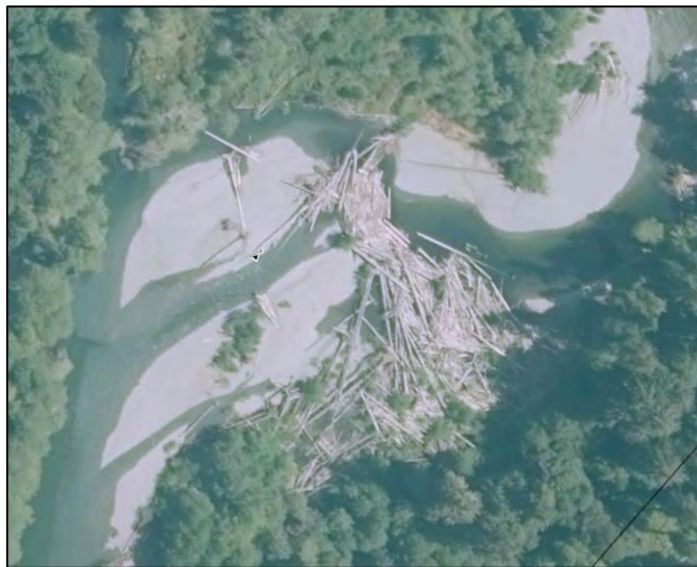
Debris jams were most common throughout reach 1, with the largest jam observed just upstream of counting station 1 (Photo 5). In most cases these jams were providing functional fish habitat.

**Photo 5. Debris jam just upstream of counting station 1 on the Conuma River.**

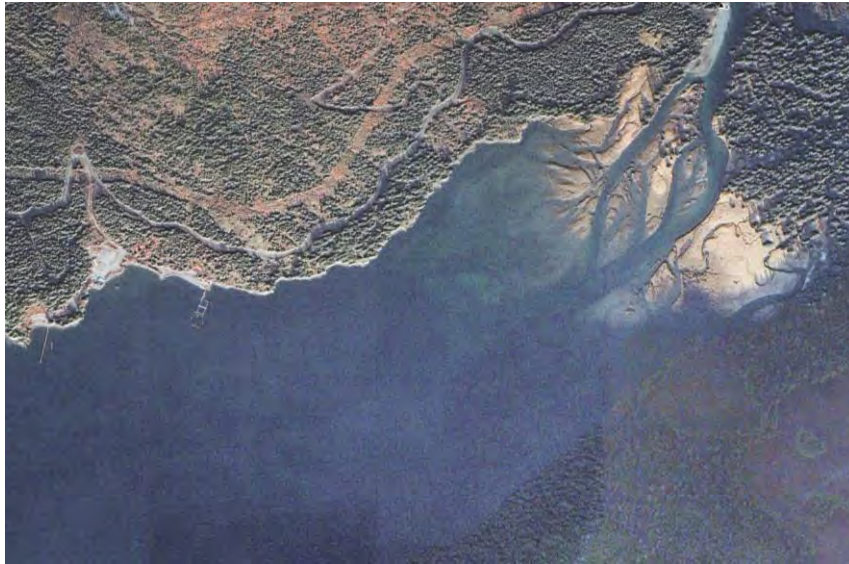
The evaluation of historic and ongoing impacts to the Conuma River estuary was limited to the information that was derived from the available aerial imagery and interviews with local experts. Generally, the Conuma River estuary has remained relatively undisturbed, with the exception of minor gravel deposition from upstream sediment sources. No significant changes in marsh and / or eelgrass habitat have been observed (C. Erikson, pers. comm.). No known log booming grounds have operated in the vicinity of the estuary, and there is a sufficient buffer between the high tide mark and adjacent roads, although past logging did occur up to the edge of the estuary. Further field investigation would be necessary to assess the impacts of past forest harvesting on the Conuma River estuary, such as excessive sedimentation deposition (resulting from erosion from upstream riparian logging). Estuary habitat disturbances has been identified as a data gap. Based on historical and current aerial image interpretation of permanent alterations to the Conuma River estuary, this habitat indicator has been ranked as low risk.

Figure 33. Present-day condition of the Conuma River estuary.
